Study of Water Pools on Runways Considering The ICAO and Brazilian Civil Aviation Agency Recommendations for Large Aircraft

João Virgilio Merighi

Latersolo Engineering Services Ltda.

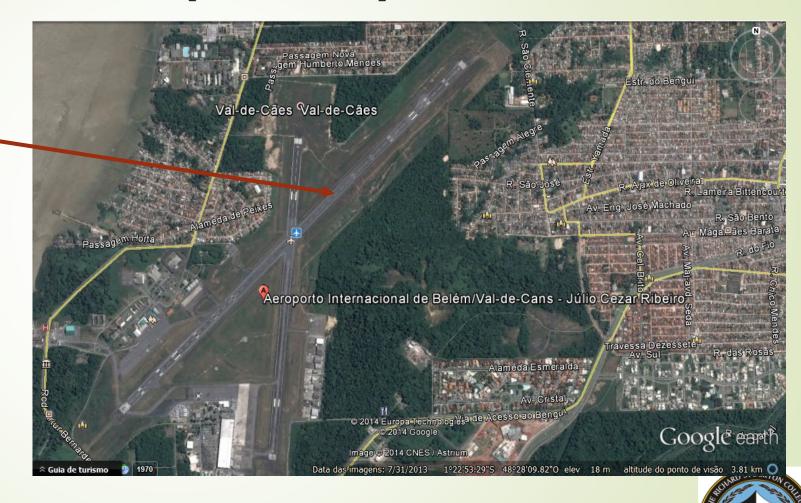
INTERNATIONAL AIRPORT OF BELÉM- PARÁ NORTH OF BRAZIL (BEL/SBBE)

MAIN RUNWAY
CLOSED A WEEK IN
JANUARY/2014
BECAUSE OF THE
FORMATION OF
WATER POOL

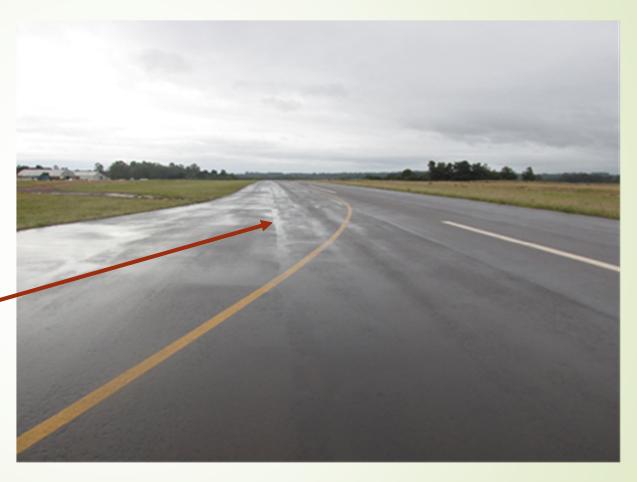
FORMATION OF A TRACK

During the construction of the upper HMA layer of asphalt pavement the formation of a track or groove at the junction of layers can occur in the longitudinal joint.

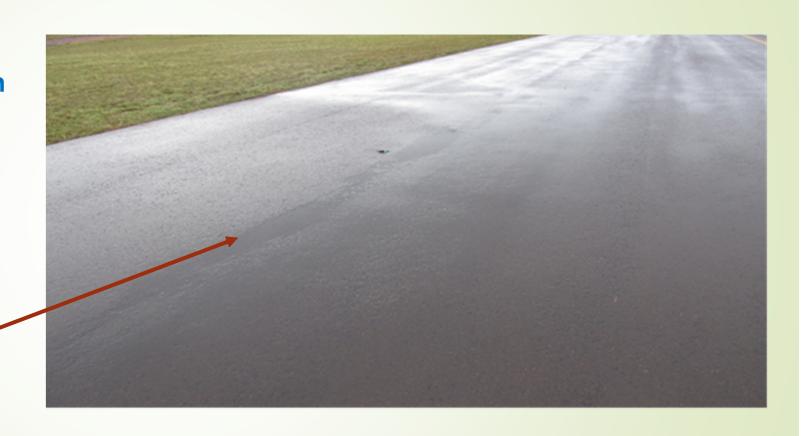
FORMATION OF A TRACK

During the construction of the upper HMA layer of asphalt pavement the formation of a track or groove at the junction of layers can occur in the longitudinal joint.

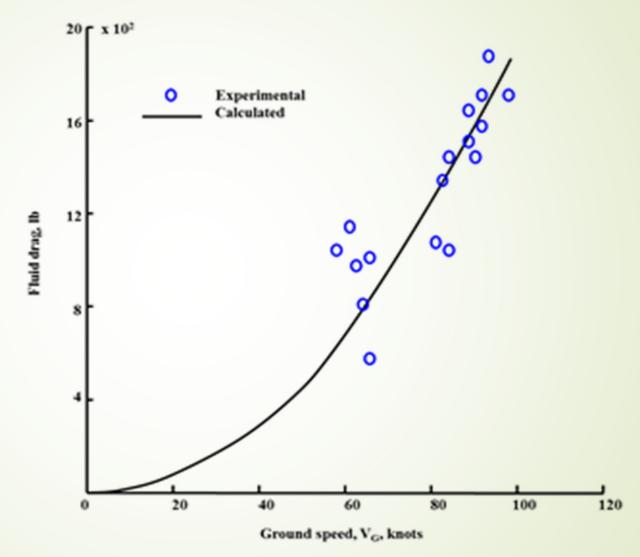
Variation of Fluid (Slush) Drag with Ground Speed on Single Wheel, Tire Pressure, 350 Ib/sq in (2413 kPa), (NASA)

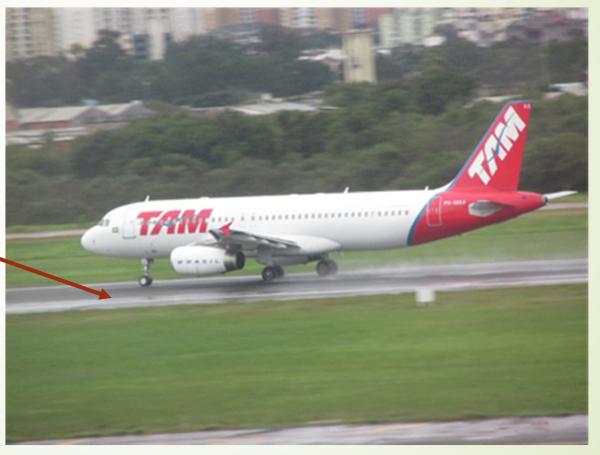
Longitudinal water pools in POA airport, south of Brazil

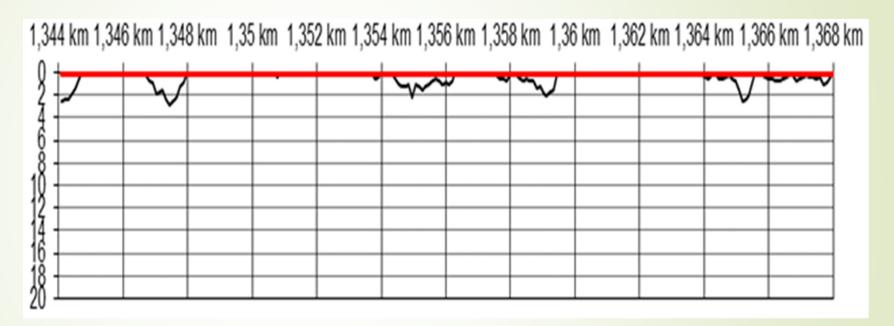
Typical results of longitudinal Roughness

- Both measures of longitudinal irregularities and average of water depth (water pools) must be done over the entire length of 3.0 m from the track axis on both sides of airfield;
- In the International Standards and Recommended Practices document, Aerodromes Annex 14, on item 3.1.14/15 f, there is only reference about the longitudinal slope change criteria

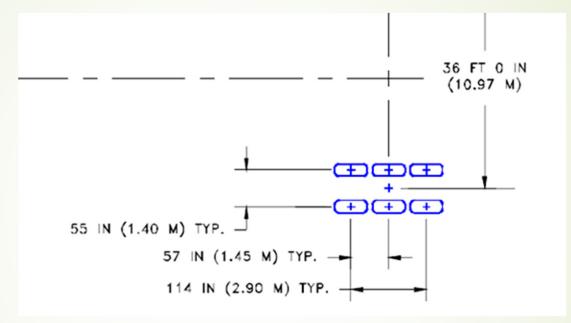
Based on the experience of air fields in Brazil, the following recommendations and the limits are offered when considering the ICAO and ANAC recommendations related to the composition of the aircraft operations and the typical landing gear:

NOT ONLY 3 m!!!!! BUT 6 m too!!!

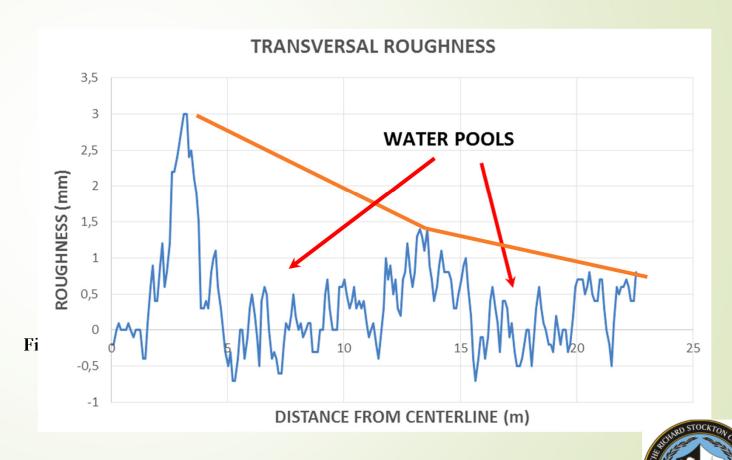
Transverse roughness showing two areas of water pools formation.
